NASA TR R-180

# REACTIVITY OF TITANIUM WITH OXYGEN

by *W. A. Riehl, C. F. Key, and J. B. Gayle*  
*George C. Marshall Space Flight Center*  
*Huntsville, Ala.*

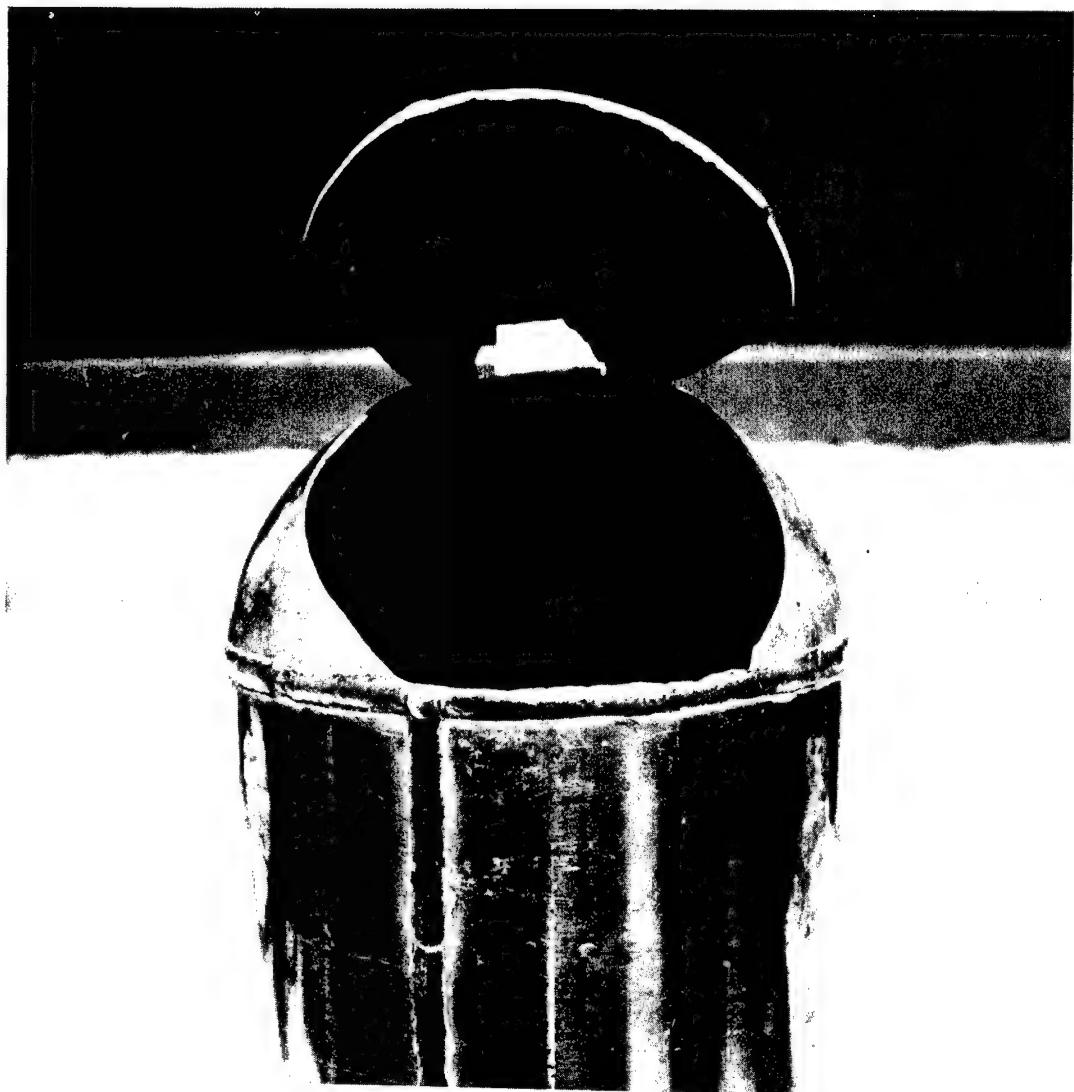
**FIGURE 18. ALUMINUM TANK FAILURE  
IN PRESSURE TEST-0.063 IN. WALL**

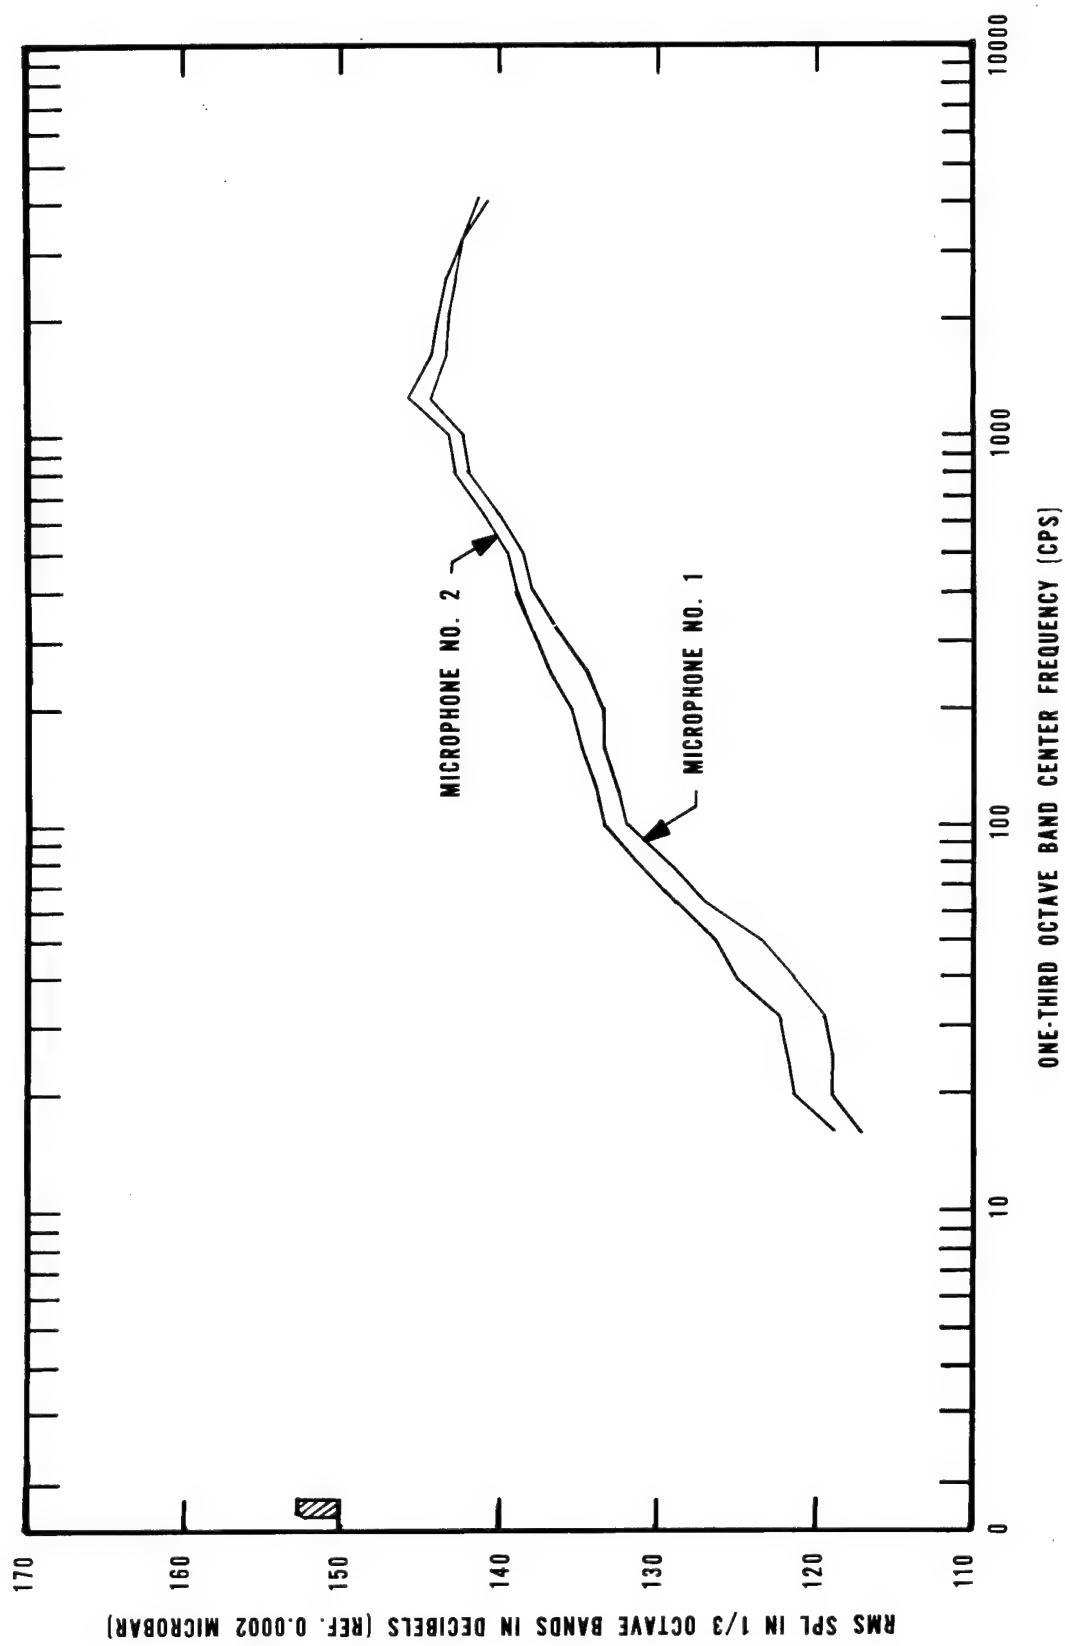
FIGURE 22. OVERALL VALUES AND FREQUENCY SPECTRA ON EITHER SIDE OF TITANIUM TANKS IN ACOUSTIC ENERGY TESTS

Four tests were conducted with the LOX filled titanium tanks exposed to a nominal sound pressure level of 150 decibels. Three of these tests were of 60 seconds duration and one was of 30 seconds, for a total test time of 210 seconds. FIG 22 depicts the average sound pressure level for all of the tests at the two microphone positions shown in FIG 21. The tanks were not affected by these conditions.

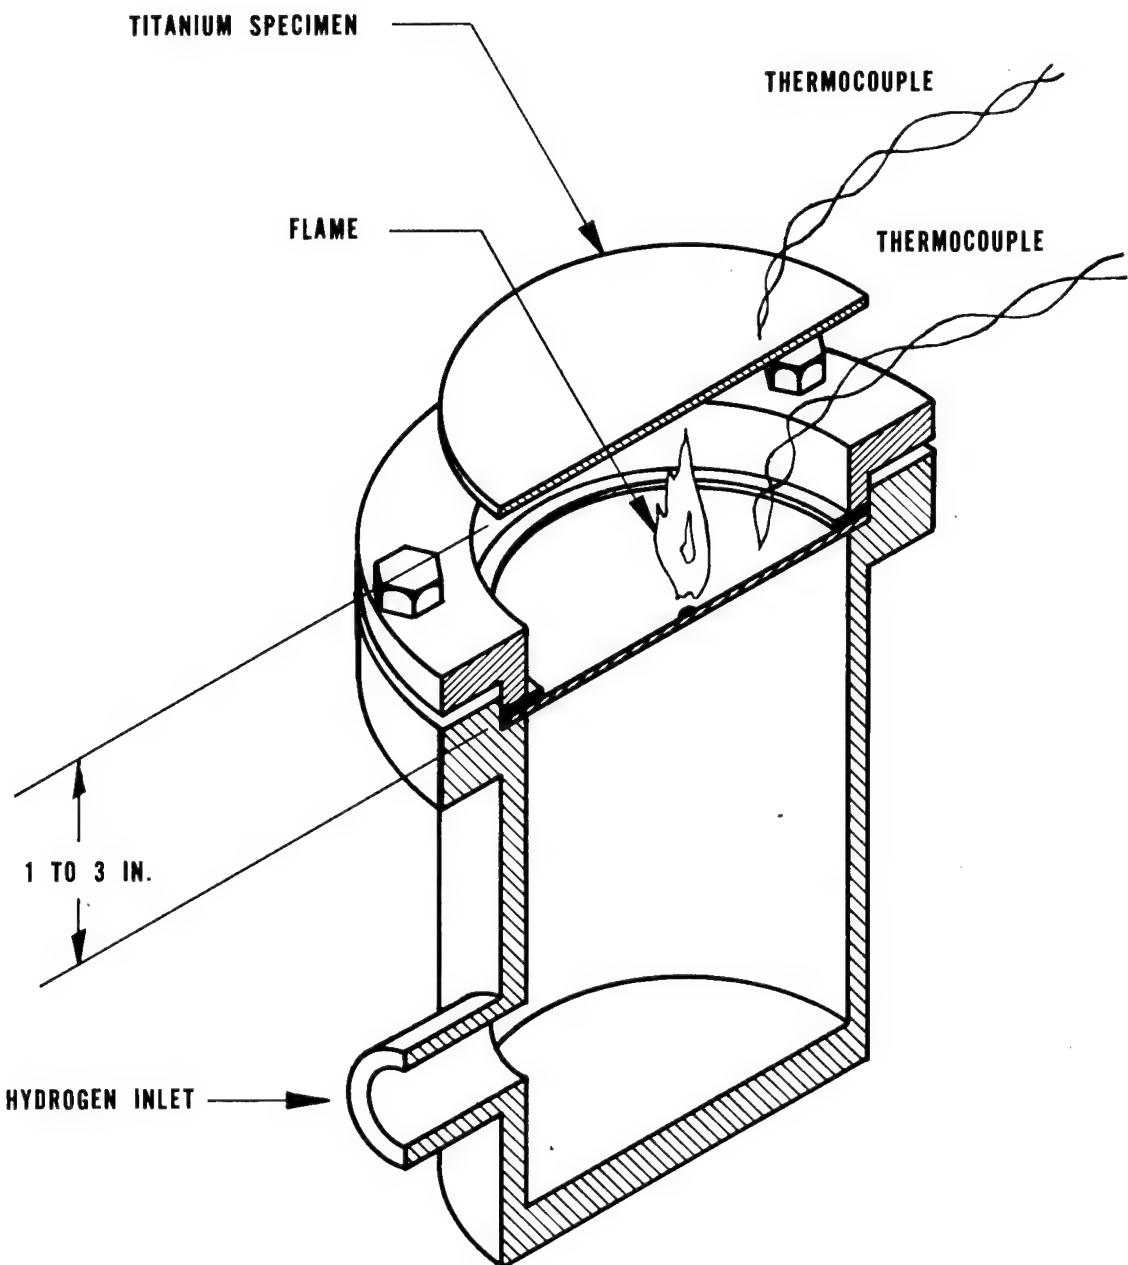
FIGURE 23. DIRECT IMPINGEMENT OF HYDROGEN/AIR FLAME ON TITANIUM

Tests were made to investigate whether direct impingement of hydrogen/air flames would ignite titanium in air. Laboratory type tests were made by modifying the titanium disc container fixture shown previously in FIG 17. A small hole (0.010-inch diameter) was drilled in the 0.010-inch titanium disc and a similar disc without a hole was placed parallel to the lower one and several inches directly overhead. A flow of gaseous H<sub>2</sub>, sufficient to maintain a pressure of 5-10 psig in the container, was begun and the escaping gas ignited by a spark. Upper surface temperatures of both discs were monitored by thermocouples (FIG 23). Four tests of approximately 10 minutes duration each were made, in which the spacing between the titanium plates were varied to obtain the highest temperatures. Under these test conditions, a spacing of one inch resulted in attainment of 1200°C (2200°F) on the top plate, and 980°C (1800°F) on the lower plate. The titanium was severely embrittled by these conditions, as would be expected, and a thin white powder coating formed on the surface (undoubtedly titanium dioxide). However, the metal did not ignite. Similar tests with 2014-T6 aluminum rather than titanium, produced melting (as expected) without appreciable reaction.

These results indicated that deleterious effects on titanium by a hydrogen/air flame are much more likely to be structural weakening, i. e., embrittlement, than ignition.

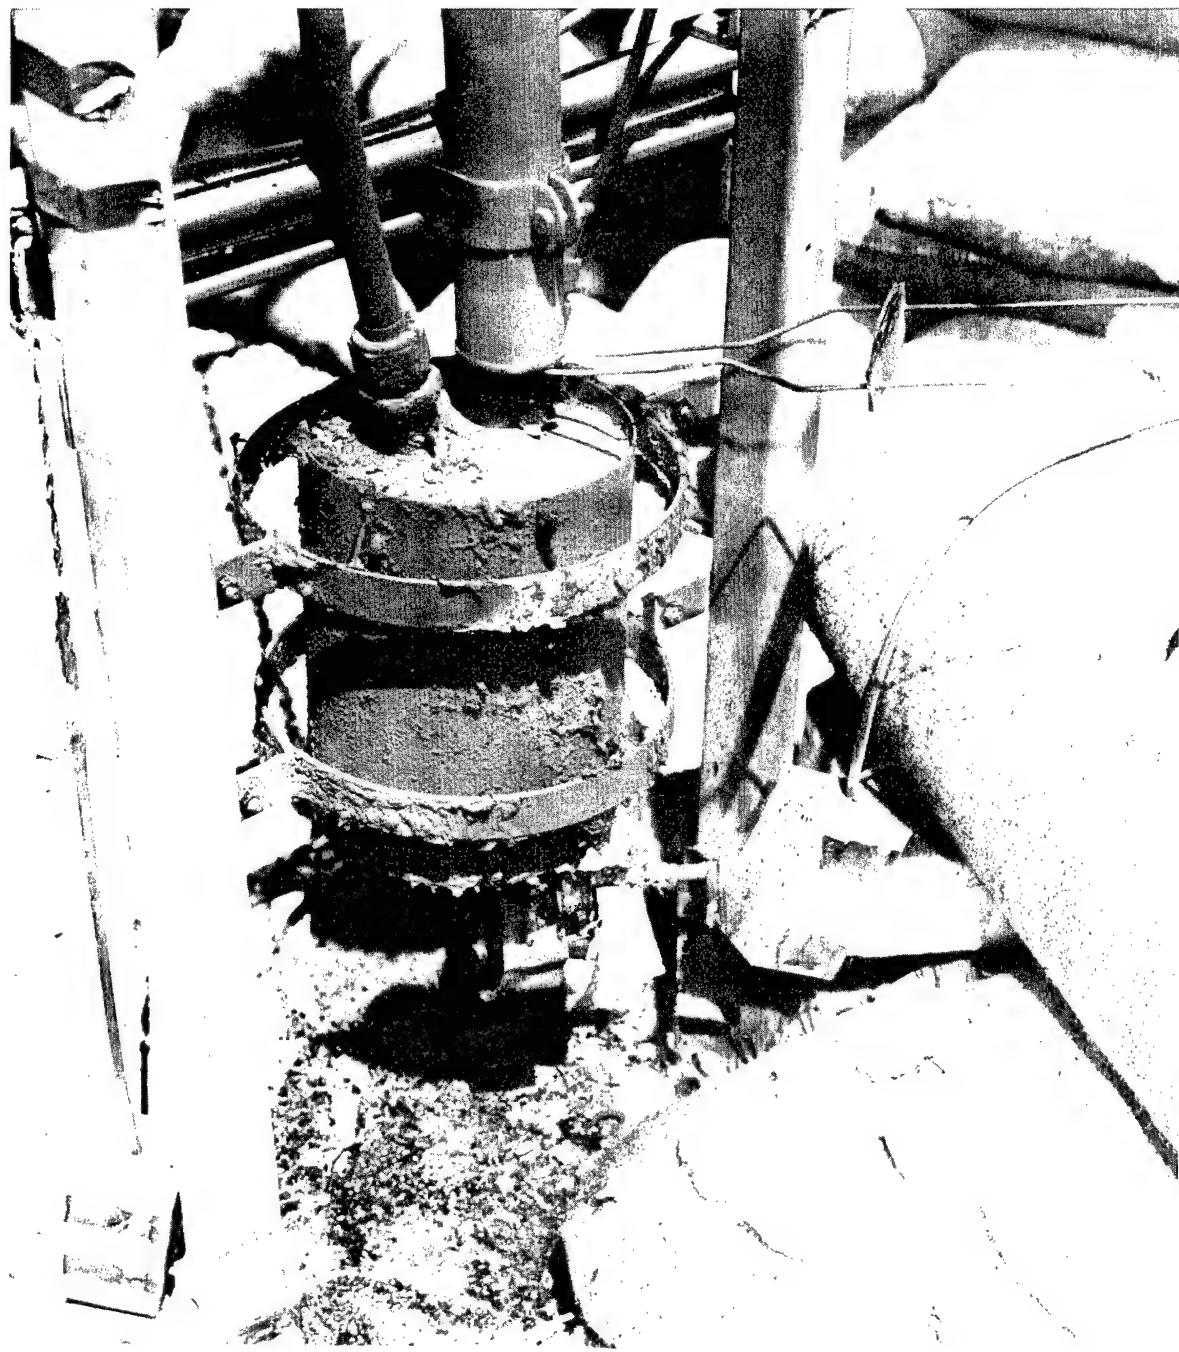
**FIGURE 24B. LH<sub>2</sub>-TITANIUM TANK TEST  
AFTER PUNCTURE AND H<sub>2</sub> BURNING**

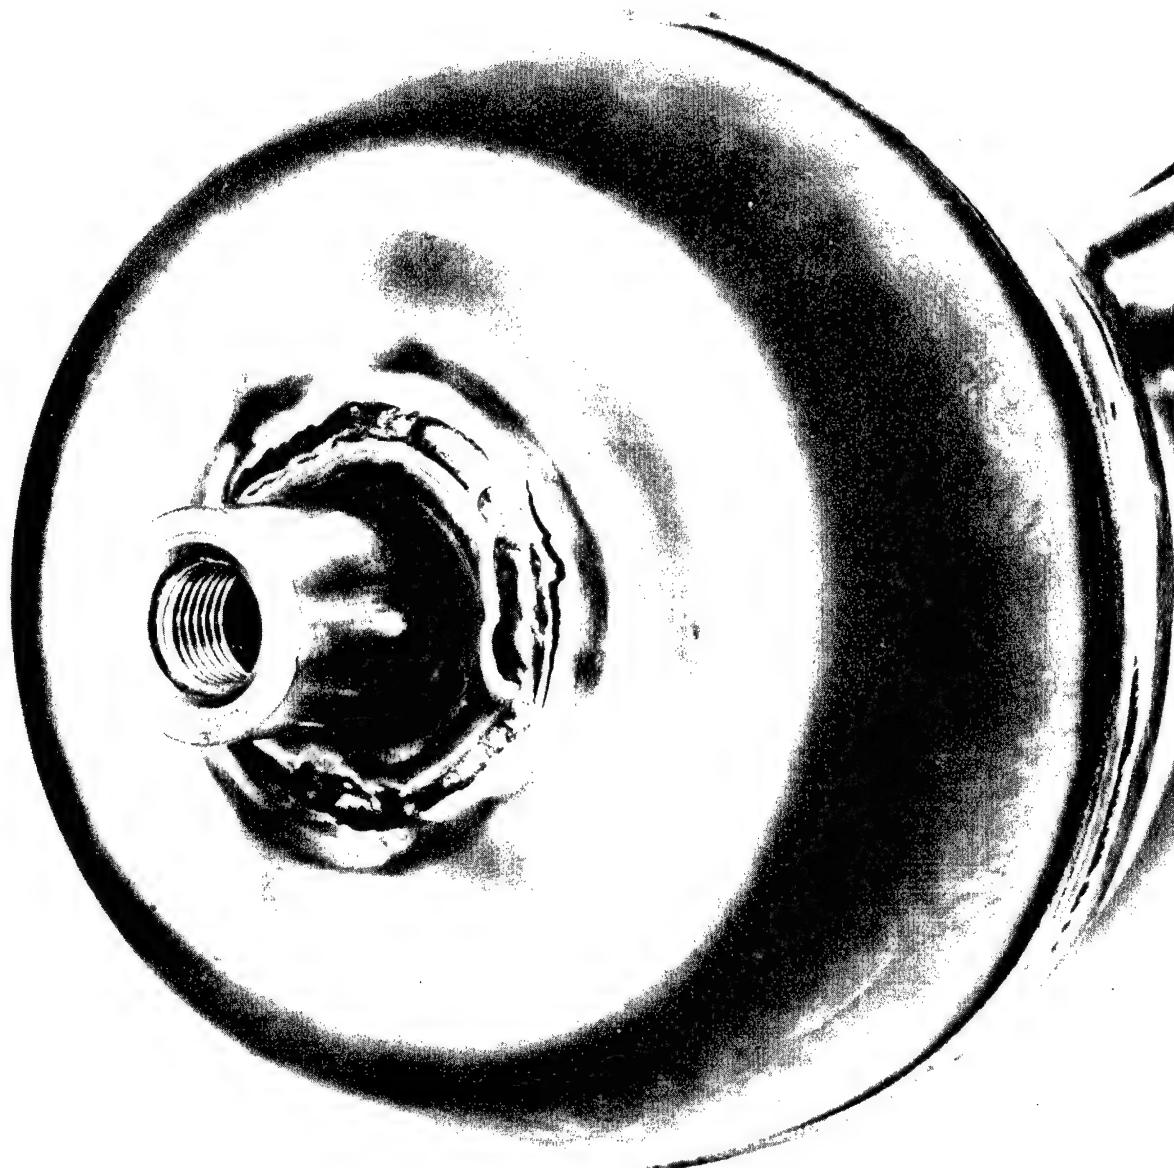
**FIGURE 26. TITANIUM VESSEL FAILURE  
AT 125 PSIG O<sub>2</sub>-0.010 IN. WALL**

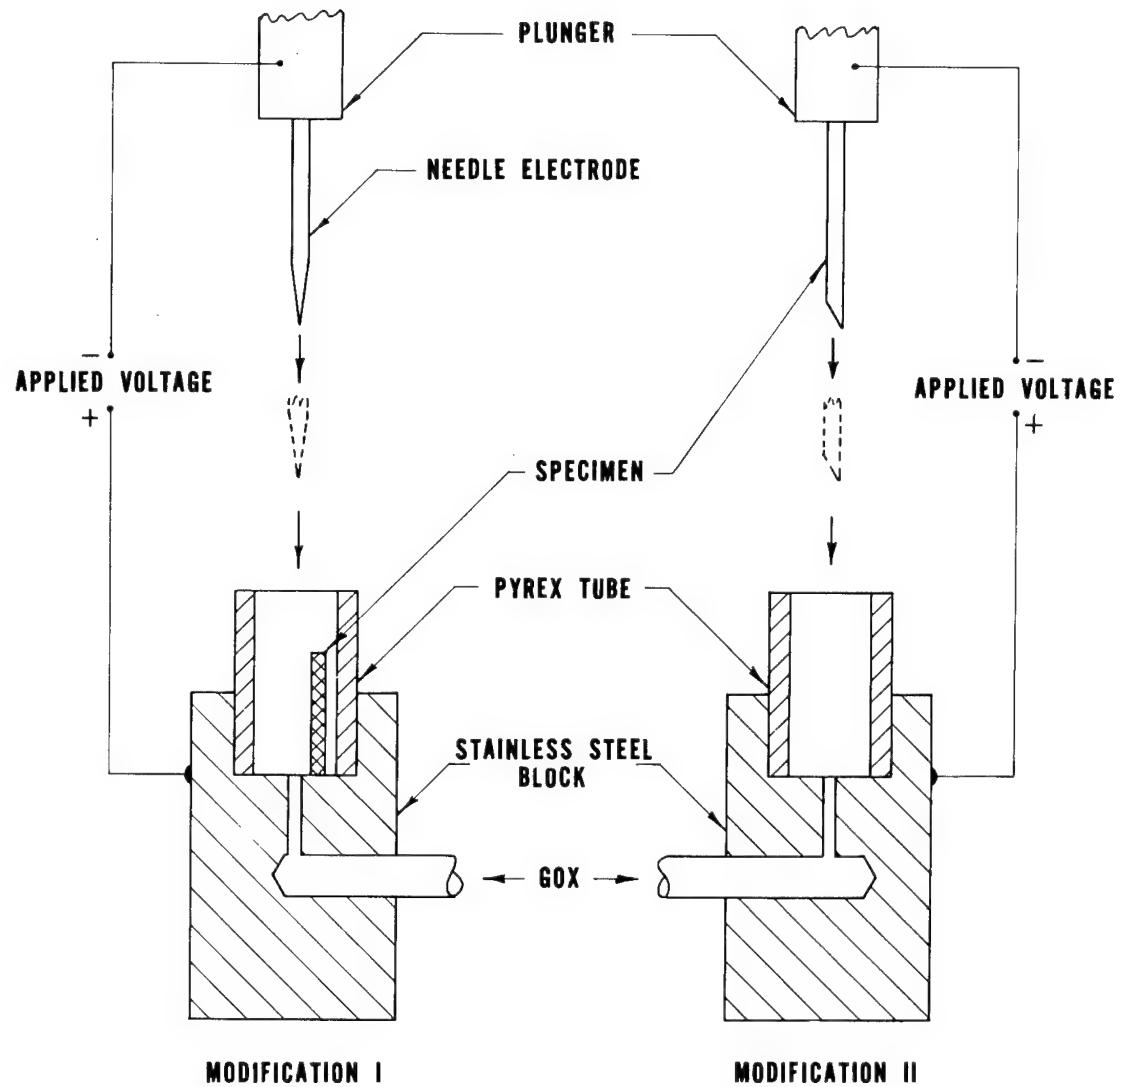
FIGURE 28. APPARATUS USED FOR SPARK SENSITIVITY TESTS

Apparatus and Procedure. The apparatus used for this investigation (FIG 28) was essentially that used for testing explosives in the partly confined condition by Brown, Kusler, and Gibson (ref. 18).

Aluminum failed to ignite with spark energies up to the maximum capacity of the apparatus (10 joules).

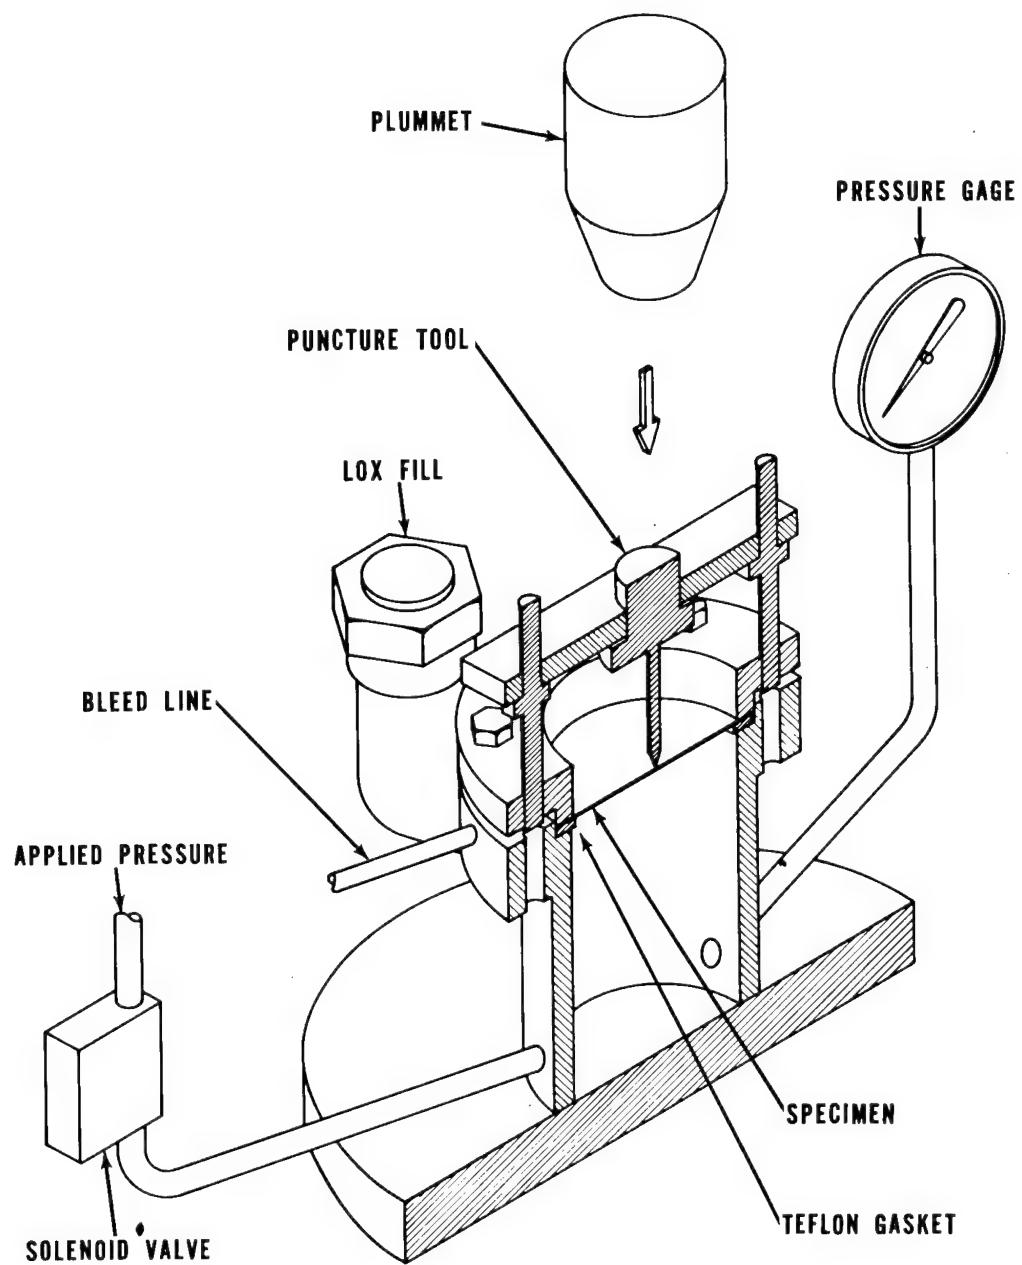
FIGURE 29. TEST SETUP FOR EXTERNAL GAS PHASE PUNCTURES

a. Gaseous Phase. The fixture for these tests is shown in FIG 29. A 2-inch disc of the sample to be punctured was used as a diaphragm to seal the gas in the lower container. Normally, the container was flushed and pressurized to 35-40 psi from a cylinder of compressed oxygen. For low temperature testing, a quantity of liquid oxygen was placed in the container and self-pressurization was used.

Test results of diaphragm puncture tests in the gaseous phase are summarized in Table 27. These included various sample thicknesses, materials, as well as ambient and low temperature gas. From the overall standpoint, reactions were obtained in a total of 49 times in 57 trials, or 86 percent of the time, with titanium - from 0.010- to 0.032-inch thick and various puncturing tools.

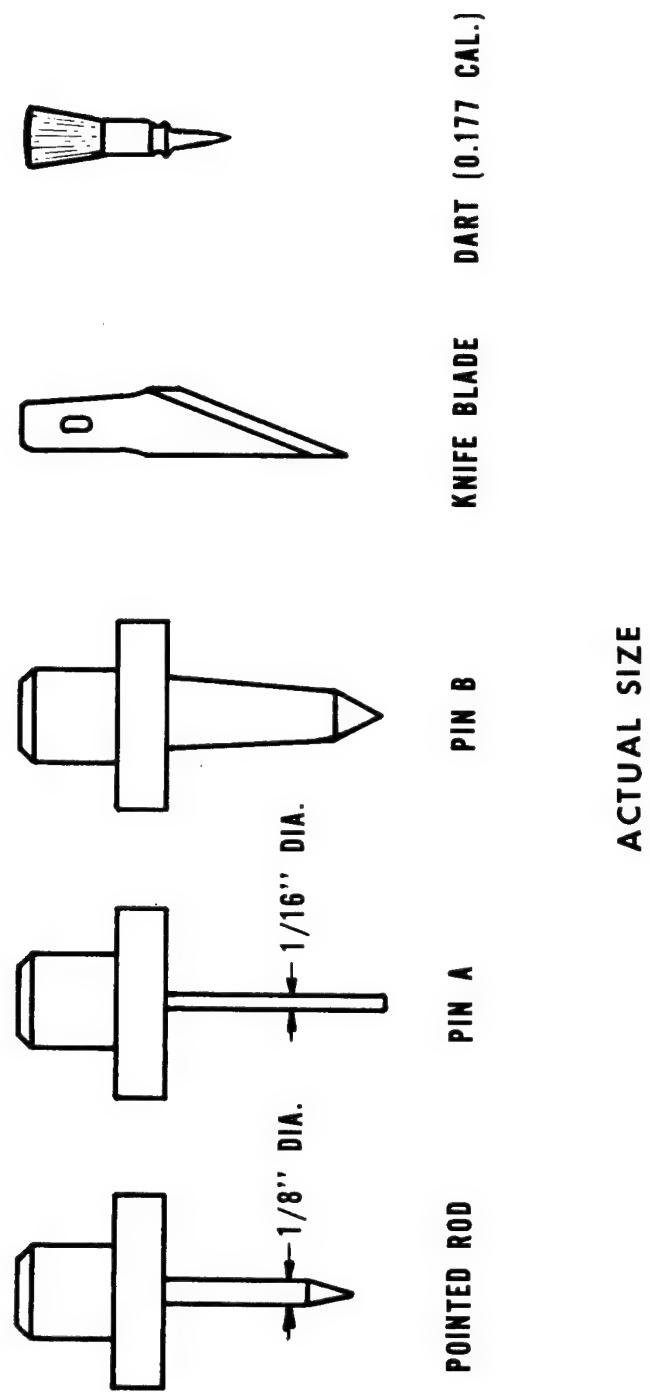
FIGURE 30. PUNCTURING TOOLS

In the preliminary phases of these tests, several shapes of puncturing tools were employed, as shown in FIG 30. Since no important differences in results were noted, the 1/8-inch pointed rod was arbitrarily selected as a standard, and used in all subsequent disc puncture tests (except the darts, which are specifically cited later). The puncturing tool was held in position by a collar and the fixture placed in the impact sensitivity tester. The plummet and guide rail of the tester were used simply to deliver sufficient force to drive the pin through the test disc. Furthermore, this operation could be done in the existing test facility, and with remote controls.

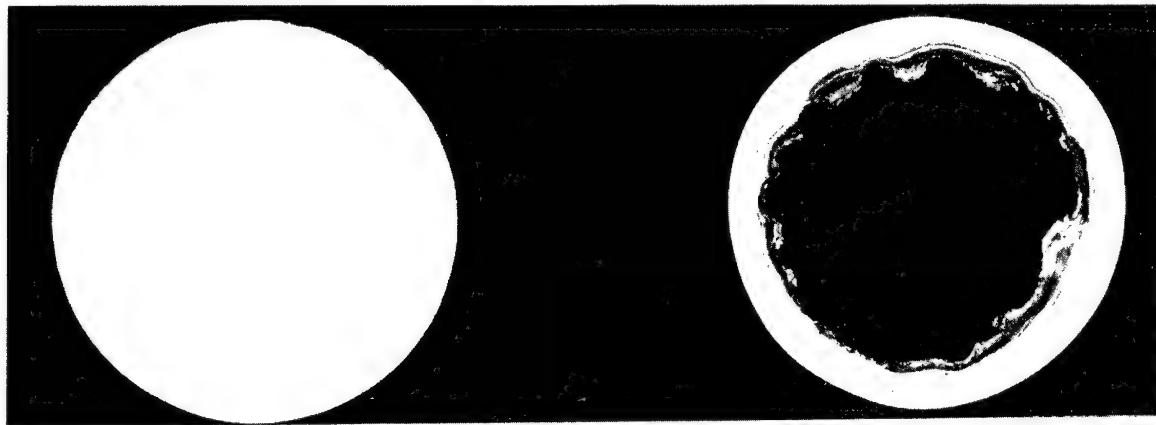
FIGURE 31. TYPICAL APPEARANCE OF TITANIUM DIAPHRAGMS  
AFTER PUNCTURE TESTS

or rapid combustion of all of the exposed titanium (FIG 31). The detonations were accompanied by a very loud explosion which usually blew open the door of the test cell (friction latch). Detonations were much more frequent in the low temperature than in the room temperature tests. This may be due to a higher concentration of oxygen present.

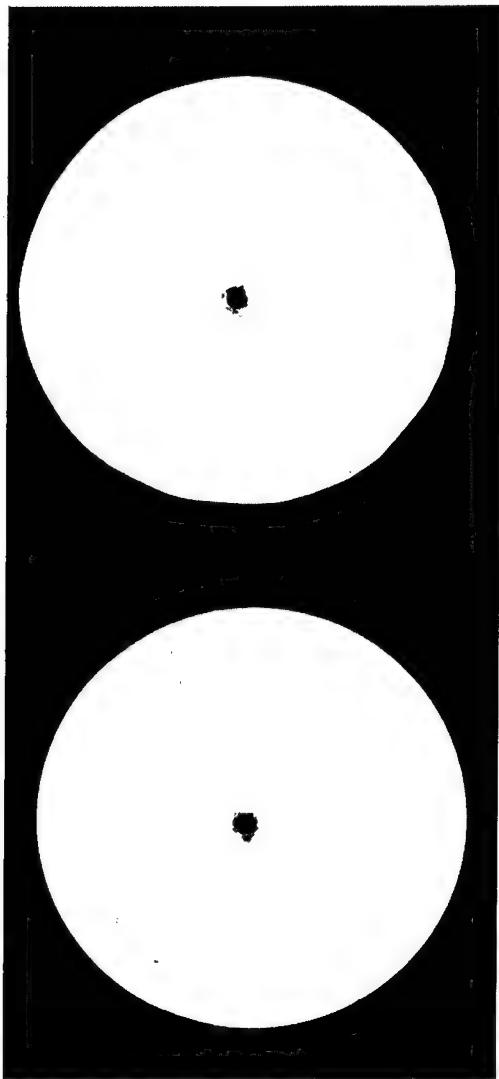
ALL SAMPLES - 0.010 IN. THICK X 2 $\frac{1}{4}$  IN O.D.-5Al-2.5Sn TITANIUM  
PRESSURIZED TO 35-40PSI. INTERNALLY WITH LOX & GOX &  
PUNCTURED IN GAS PHASE BY 1/8 IN. DIAM. POINTED ROD.

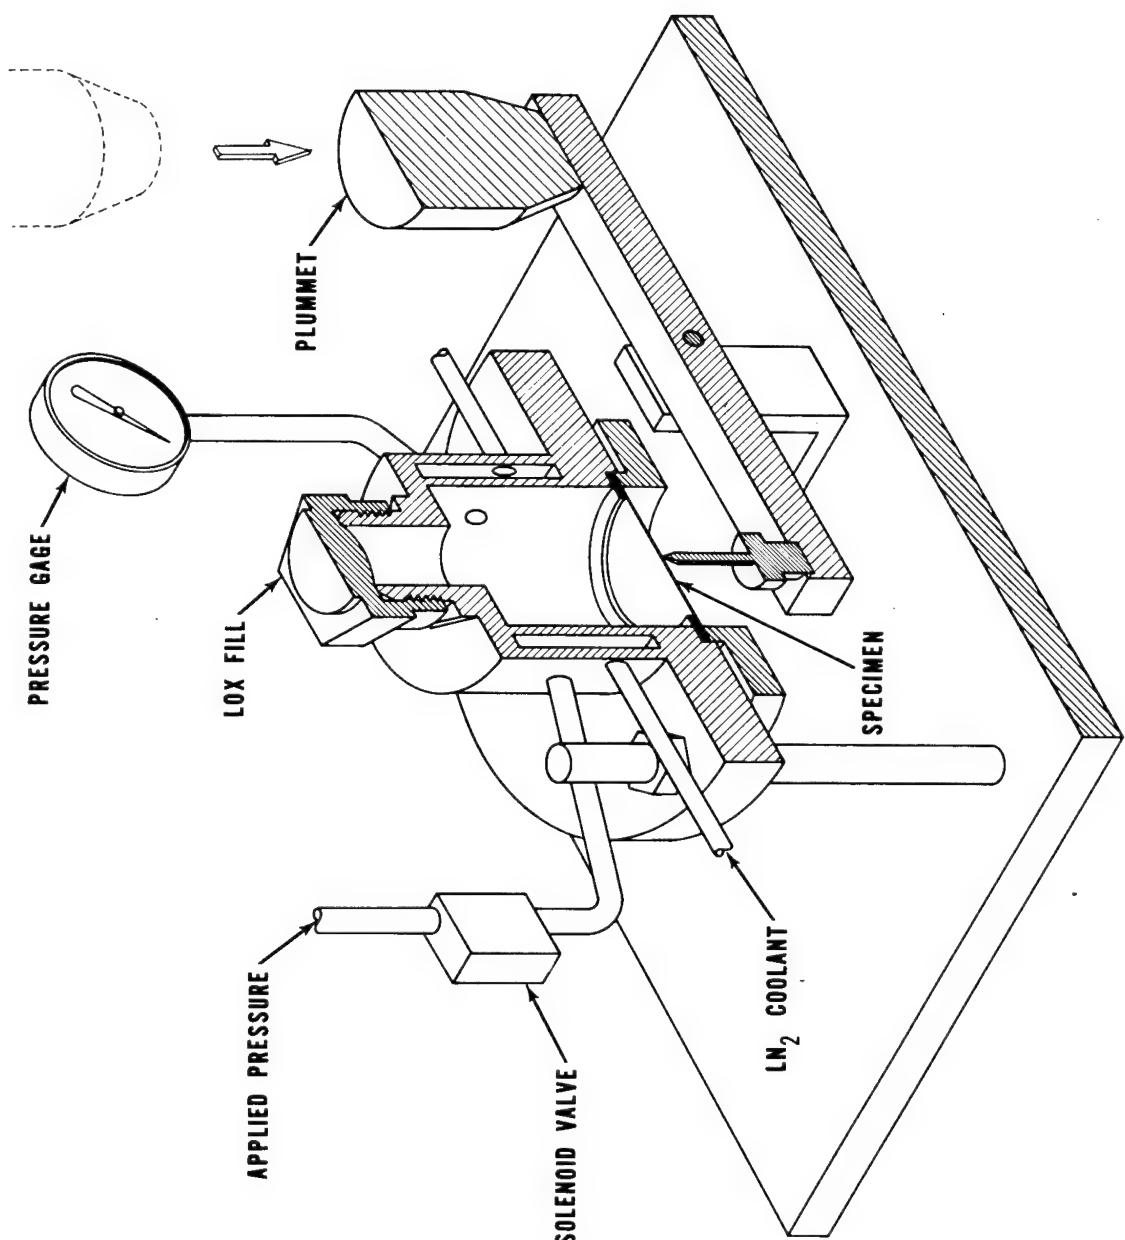
FIGURE 33. TEST SETUP FOR EXTERNAL LIQUID PHASE PUNCTURES

b. Liquid Phase. Studies also were made to investigate the effect of penetrations with liquid oxygen on the reverse side. In these tests, the test diaphragm was placed in the bottom of the container and punctured from below. This was accomplished by using the plummet of impact sensitivity tester to deliver the puncturing force through a "see-saw" lever arm as shown in FIG 33.

into the 0.010-inch thick titanium diaphragm. One "sustained burning" reaction, and three flashes resulted in four trials. A control test in which the darts were fired into a diaphragm in air showed that the punctures were only several hundred microns in diameter.

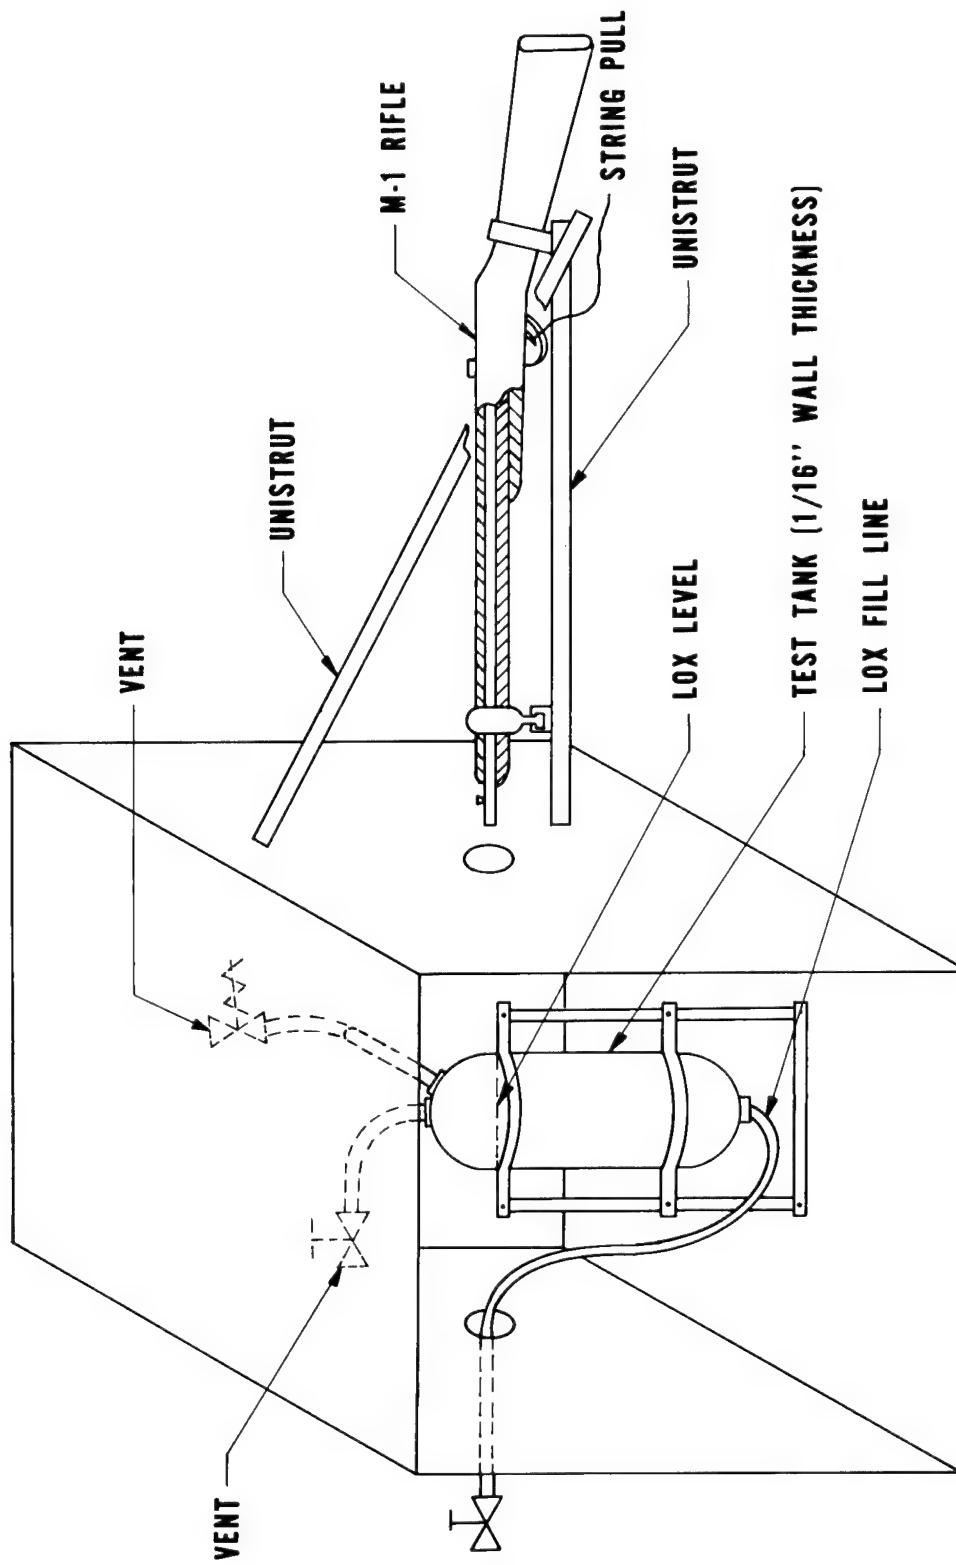
**FIGURE 34. TANK PUNCTURE APPARATUS (M-1 RIFLE SETUP)**

The most drastic puncture test used was penetration by a standard M-1 rifle bullet, i. e., caliber .30-06 bronze jacketed lead slug. The test setup is shown in FIG 34. The first test was made with the aluminum tank. No reaction occurred. The bullet penetrated both sides of the tank, leaving clean holes.

The titanium tank exploded under the same conditions. Remains of the tank are shown in FIG 35. High speed motion pictures disclosed that fast and violent combustion occurred immediately on penetration, showering the area with flying particles of burning titanium. These burning particles subsequently exploded in flight. The reaction appeared to be subsiding somewhat when, several tenths of a second after initial penetration, a detonation occurred. The test was not provided with blast instrumentation; however, the blast was very powerful.

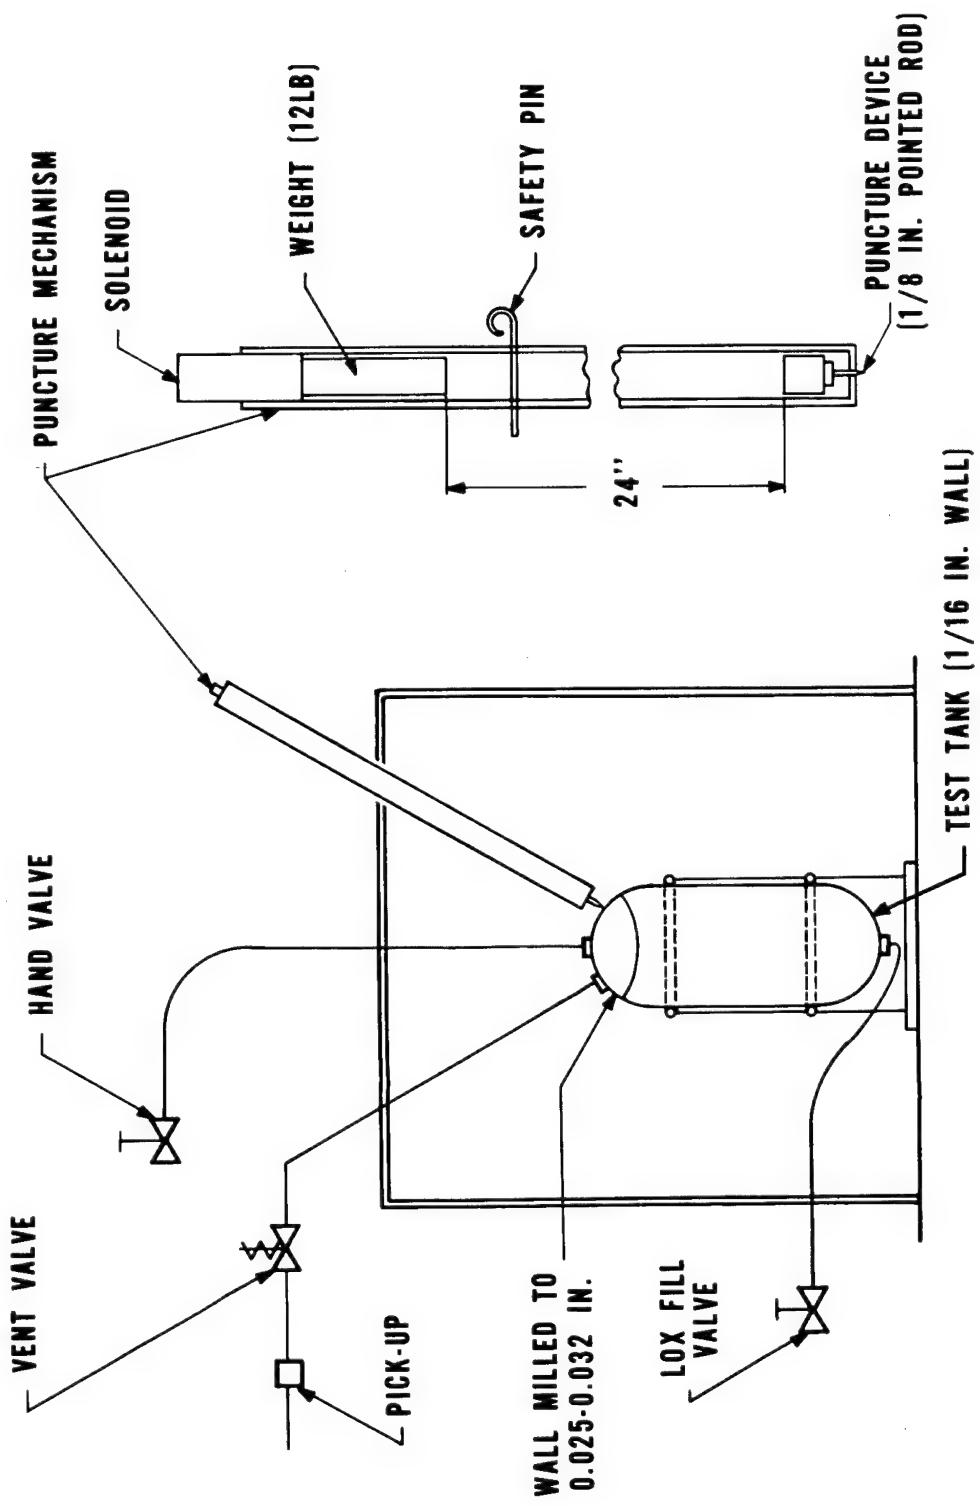
FIGURE 36. TANK PUNCTURE APPARATUS-PIN TYPE TEST SETUP

Tests also were made with the milder pin type punctures used in the diaphragm tests. The two milled head tanks were used for these. The test setup and puncturing mechanism are shown in FIG 36.
